PIPELINE PERFORMANCE EXPERIENCES DURING SEISMIC EVENTS IN NEW ZEALAND, 1987 TO 2015

Frank W. O'Callaghan, Iplex Pipelines NZ Ltd, New Zealand

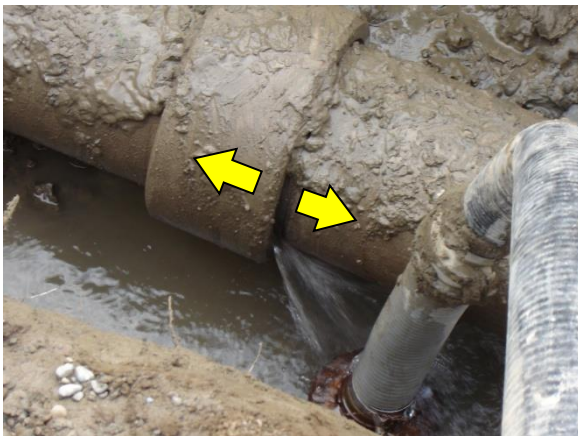
Figure III - Tension effects in AC pipe joint, Sewell Street Kaiapoi, axially aligned with the Darfield epicenter, 2010

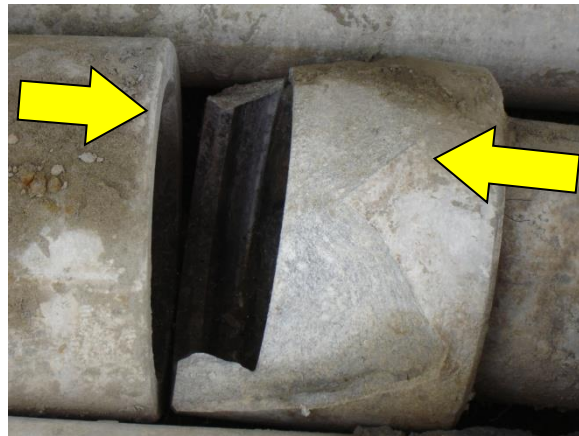
Figure IV - Compression effects in AC pipe joint, Sewell Street, Kaiapoi, axially aligned with the Darfield epicenter, 2010

Pipe/joint type	Compressive Phase movement in Liquefiable ground	Location/ Seismic Event
AC pressure and sewer	Localised 45 deg compression fracture of rubber ring coupling joints and crushed pipe spigots. (Figure IV and Figure VI)	Edgecumbe Christchurch Kaiapoi
EW sewer	Disintegration of whole pipe into random shards, or localised brittle ring fracture of mortar sealed bell and spigot joints.	Edgecumbe Christchurch Kaiapoi
VC sewer	Disintegration of whole pipe into random shards localised brittle fracture of rubber ring bell and spigot joints.	Christchurch Kaiapoi
RRRC sewer	Localised “telescoped” brittle fracture of rubber ring bell and spigot joints.	Christchurch Kaiapoi
PVC pressure and sewer	Localised ductile pipe barrel section folding/buckling. Localised “telescoping” of joints (Figure X), (caused by the pipe spigot being driven through the socket bell, and beyond into the pipe bore itself). Ductile fracture of sewer service lateral junctions, ductile tearing at socket joints,	Christchurch Kaiapoi

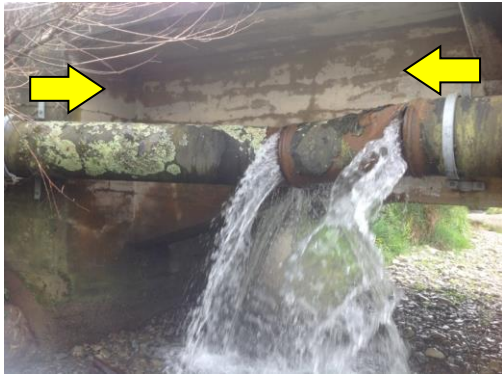
Figure V - Compression distortion and separation of RRJ joints in CLS watermain, 2014

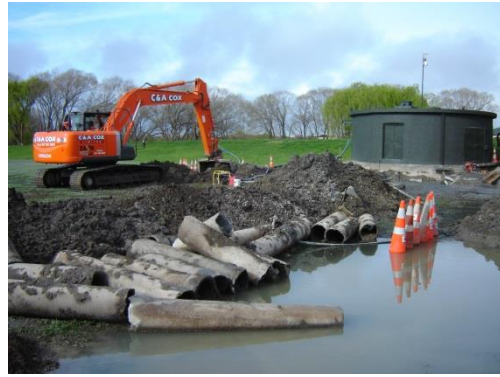
Figure VI – Compression fractures of pipe ends and joints in AC sewer rising main, Charles St, Kaiapoi, axially aligned with the Darfield epicentre, 2010 (Replaced with Biaxially Orientated PVC (PVC-O)

Biaxially orientated PVC (PVC-O) pressure pipe installed in 2010 to replace the destroyed AC sewer rising main at Charles St in Kaiapoi, (Figure VI) remained undamaged, during the Christchurch and Lyttelton events of 2011 and all subsequent aftershocks.

Biaxially orientated PVC (PVC-O) pressure pipe installed in 2010 to replace the destroyed AC sewer rising main at Charles St in Kaiapoi, (Figure VI) remained undamaged, during the Christchurch and Lyttelton events of 2011 and subsequent aftershocks. No seismic failures were reported from the relatively limited PE gas pipe network in Christchurch. PVC and PE pipelines laid in late 2011 between the February 2011 and December 2011 events had no damage reported. However, like all pipe materials observed, the consistent conclusion from observation is that PVC and PE have their mechanical limits and when those limits are exceeded, should be expected to fail or require substantial repair, similar to other pipe materials. PVC-U gravity sewer pipes and fittings are currently widely used in Christchurch City for new residential subdivision developments, and network rebuild. VC and EW pipes are now not used in the Christchurch area, including for industrial lines where PVC-u has been adopted. In the liquefiable east-central and eastern zones of Christchurch, where the weakened ground cannot reliably support thrust blocks, or even open trenches, fusion joined PE is the predominant replacement pressure watermain pipe material used. In other non-liquefiable areas of western, northern and southern Christchurch City, conventional spigot /socket RRJ PVC is widely used for open cut installation, as the work footprint advances beyond repairs/reinstatement and into “green fields” works for new residential subdivision and commercial developments. In neighboring Waimakariri District and Selwyn District, also affected by the Canterbury earthquakes, PVC-U pressure pipes are approved for new and replacement open cut water mains in non-liquefiable zones, with PE-100 the predominant material for pressure sewers, and trenchless drilled installation. In other South Island Council regions, south-west, west and North-east of the Canterbury/Christchurch zone, and exposed to seismic risk from the main Alpine fault itself, pipes in PVC-O, PVC-U, PVC-M and PE are widely accepted and used. Restrained joint PVC-U and Fusible PVCTM have also been used for trenchless replacement of EW Gravity Sewers.

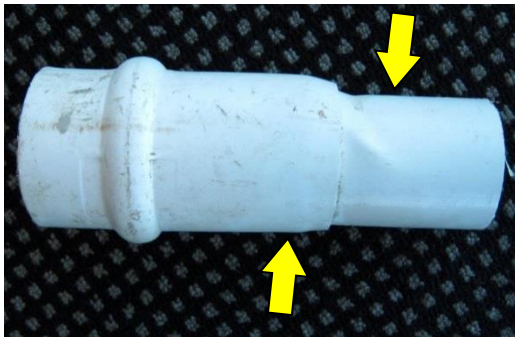
In the Waimakariri River flood plain extending under Christchurch City and Kaiapoi, sharply defined liquefiable ground zones exist, intermixed with non-liquefiable ground zones, at varying depths. The intensity of pipe damage observed alternated from often extensive, or total, in the liquefaction or lateral spread zones, to examples of minimal or no damage observed in the same pipes in adjacent non-liquefaction areas. A close association between approximate axial alignment of the pipe with the earthquake epicentre and type of pipe response was seen, in pipes of AC, CLS, and PVC-U at Edgecumbe, Carterton (Eketahuna event), Kaiapoi, Pines Beach / Kairaki Beach (Darfield event), and Christchurch. Resulting localised movements at pipe joints suggested the passage of rapidly alternating axial compressive or expansive movements in the liquefied ground. Pipes in streets aligned with the epicenter in liquefiable ground, displayed alternating expansive movement (Figure III), or axial compression (Figure IV, and Figure VI), whereas pipes positioned approximately tangential to the epicenter “around the corner”, showed lateral shear effects. (Figure VII and Figure VIII)

Figure VII – Shear effects with ductile response, in RRJ PVC-U of late 1970's age, Christchurch, 2010

EW, VC, RRRC	Localised fracture and separation of bell and pipe barrel.	Gisborne Palmerston Nth Dannevirke Christchurch
PVC	Ductile distortion of pipe and joint, no leaking. (Figure VII and Figure XI)	Gisborne Kaiapoi Christchurch
CI	Fracture of pipe barrel at flange connections.	Christchurch
DI	Localised distortion/disorientation of coupled barrel sections with DI coupling fractures, (in an aerial pipe bridge application), movement beyond compressive capacity of material.	Christchurch
CLS	CLS pressure pipe systems: Localized “telescoping” of joints, tearing and “unraveling” of the spiral weld in the pipe barrel from movement beyond compressive capacity of material.	Christchurch Carterton (Eketahuna)
	Slumping or Lateral Spread in Liquefiable ground	
RRRC	Settlement off grade, pipe barrel fracture, joint fracture, lateral separation, separation from structures	Christchurch
PE-100 pipe systems	Tensile separation at electrofusion joints where movement beyond tensile capacity of joint at the fitting. Tensile separation (yield and break) of pipe, used as a liner in rehabilitation of CI watermain, where movement was beyond tensile capacity of pipe barrel.	Christchurch

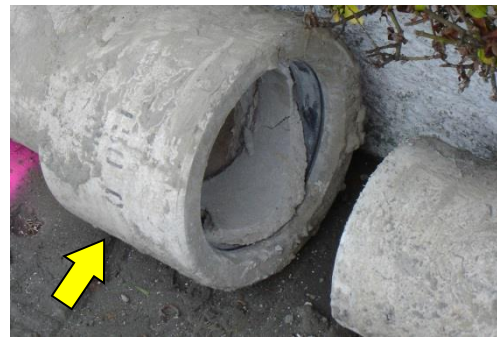
Figure VIII – Shear effects in AC pipe joint, Jollie Street, Kaiapoi, with tangential alignment to the Darfield epicenter, 2010

axial movement did not exceed spigot insertion length), movement beyond tensile capacity of material. (Figure X)	
CI pressure	Localised pull-out of couplers, displacement of screw gland joints and lead wool packed joints.	Christchurch
DI pressure	Joint separation, movement beyond tensile capacity of material.	Christchurch
CLS, GS	Separation where movement beyond tensile capacity of material.	
PE-100	Separation at Electrofusion joints where movement beyond tensile capacity of material.	Christchurch
PE-80, HDPE	Separation of service laterals at restrained mechanical joints where movement beyond tensile capacity of material. Tensile separation of pipe barrel where lateral spread movement beyond tensile capacity of material.	Christchurch
	Lateral Shear movement in Liquefiable ground	
AC	Localised shearing of spigot inside the bell assembly. Pipe barrel often left in reasonable condition, but with the end cracked off and separated. (Figure VIII)	Kaiapoi Christchurch Edgumbe

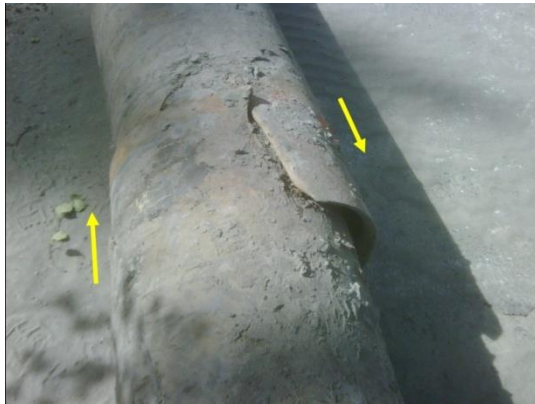
Figure IX - Compressed joint movement in CLS water main, Christchurch

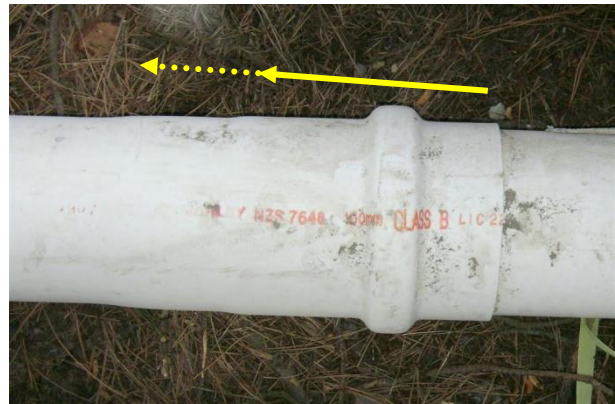
Figure X – Compressed ductile joint movement in PVC-u water main, Christchurch

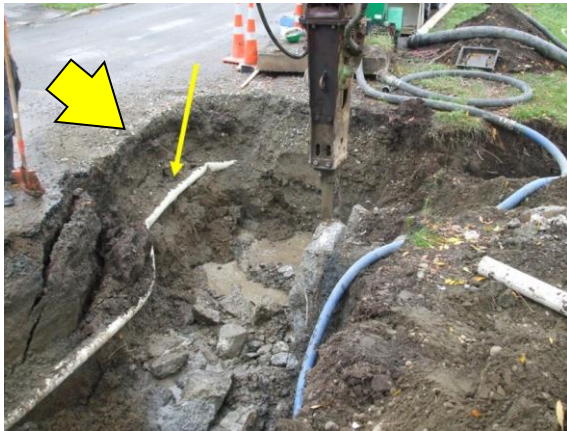
Pipe material behaved in surprising ways. In Christchurch, DN 100 PVC-M pressure pipe, manufactured in 1996, was displaced by sudden lateral spread and squashed behind a large concrete sewer chamber in the Avon river bank (Figure XI). The pipe was found to be still under pressure with reduced flow. The RRJ “Z” joint in the middle of the displaced pipe section which had “pulled” longitudinally about 15 mm, but had permitted the expansive movement, undamaged.

Figure XI - Distorted but still operational, DN100 PVC-M water pipe with joint, Christchurch

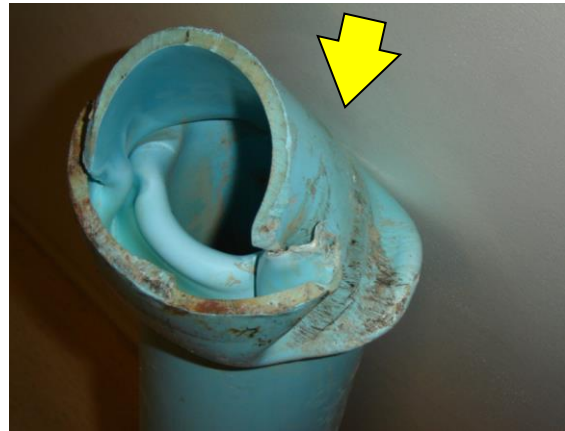
Figure XII - Ductile axial compression folding in PVC-U pipe, Gayhurst Road overbridge

At the Gayhurst Road over bridge crossing the Avon River in Avonside, Christchurch, lateral spread rapidly drove PVC-U watermain axially into the bridge abutment, to cause ductile axial buckling (Figure XII), and disintegration of the CI pipe and joints in the bridge. The crossing connections were quickly repaired with PVC pipe and mechanical couplers, requiring low operator skill, and no electricity to install.
