# INFRAPIPE MANUAL FOR INSPECTION, MAINTENANCE, MODIFICATION & REPAIR

This Manual covers the requirements for KRAH Profile pipe DN450-3200 and inline extruded CIVILPIPE DN225-DN1000. For inspection, including the optimum use of jetting equipment, and for modification or repair (from extrinsic damage) and confirms that no maintenance is required for HDPE. Contact INFRAPIPE for information on these products if required. For installation and testing see the relevant Installation & Test Plan (ITP).

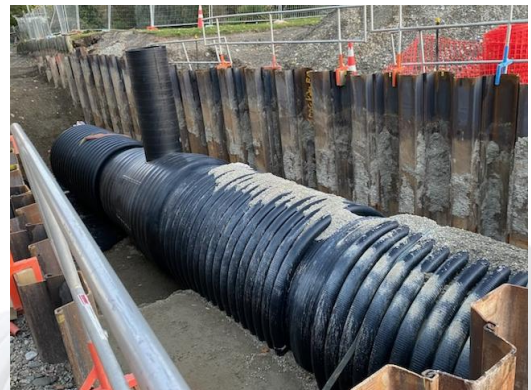
INFRAPIPE can also be found in solid wall pipes (or sections thereof) as shown above which have no core tube and are one solid continuous layer of resin. In the example to the right the main line in profile pipe then has an added outer layer for the section where the riser is welded in, and the riser itself is made from solid wall pipe.

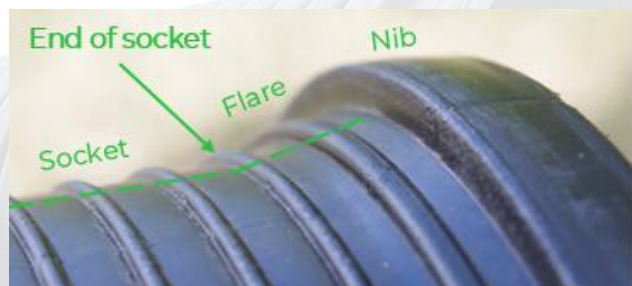
## CIVILPIPE PROTECTIVE NIB PREVENTS SOCKET DAMAGE

CIVILPIPE is a next generation twinwall product. The most important advancement is the development of a **protective Nib for the socket** to prevent damage during transit or installation. Additionally, the socket is flared before the nib by 3mm (225) to 5mm (450) to make insertion easier. As per the diagram and picture below, after the full length of the socket, the ID and OD of the pipe increase again before terminating in a rigid box section type design.

This U section plays no part in the sealing process – the rubber ring sits between the ribs 1 & 2 or 2 & 3.

**When inspecting CIVILPIPE, damage or compression to the Nib is acceptable as its purpose is purely to protect the socket. Only deformity to the socket section itself (below) is of concern.**

- ✓ **Nib prevents damage**
- ✓ Makes installation easier
- ✓ The taper allows for a very secure seal
- ✓ Longer socket makes life easier

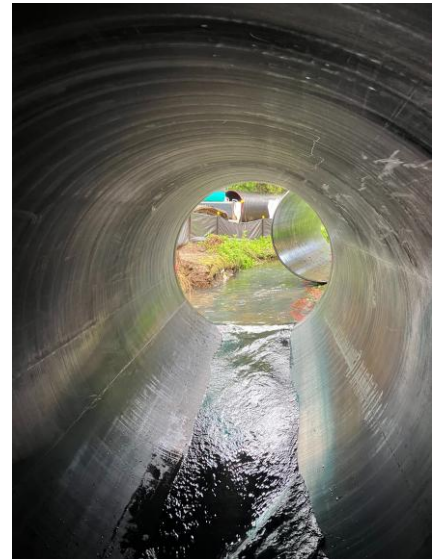
### ABRASION RESISTANCE – PRODUCT LIFE (DARMSTADT TEST)

*Abrasion curve of various pipe materials according to the Darmstadt procedure.*

**NB The above diagram is taken from a European paper, GFK is GRP/FRP.**

The Darmstadt procedure, which has been the standard for abrasion testing since the 1960s, simulates the abrasion and resulting wear of liners and pipes that would occur in actual operating conditions by tilting a pipe section containing a mix of sand, gravel and water through 22.5 degrees above and below the horizontal for at least 100,000 cycles. The results for PP or PE pipe show a much greater resistance to abrasion and hence operating life is significantly longer.

Conduct the internal cleaning of the pipe in accordance with [PIPE POP025 Water Jet Cleaning of Plastic Pipes](#). Unlike concrete and GRP, thermoplastic pipes do not degrade or abrade as a result of water jet cleaning conducted correctly. HDPE/PP have the greatest abrasion resistance as per the Darmstadt test below.

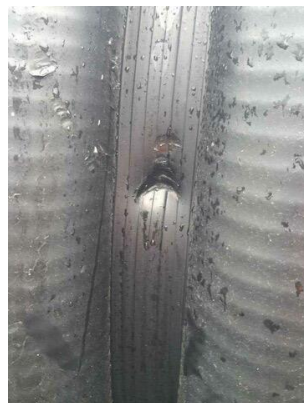
### DENTS

Minor dents or bulges can be repaired with heat and/or extrusion welding; larger ones will require sectional replacement. These examples here are easily repaired with heat alone.

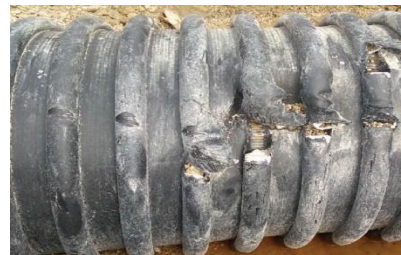
### STEP 1: DETERMINING THE SIZE OF THE DAMAGE

It is important to expose as much of the damaged pipe as possible so ensure that excavation is done extremely carefully and where possible use hand tools. To determine the size of the damage by taking measurements and photographs that can be sent to the INFRAPIPE™ appointed Project Manager. They will quickly determine the appropriate methodology for repairing the damage.

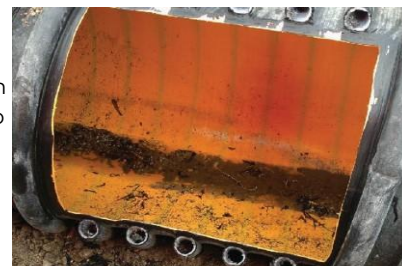
### STEP 2: STARTING THE REPAIR

For the damage shown to the left, a HDPE patch repair is the most appropriate repair methodology as the damage is easily accessible. The damaged area will need to be removed and then the area where welding will take place is to be cleaned with isopropyl alcohol and lint free rags. As a watertight weld is required it is important to remove any potential contaminants from the weld zone. Once the hole is cut a final measurement of the patch will be taken. It is important prior to welding that the inside layers of the HDPE pipe are bevelled with a router or a hand scraper to minimise the potentially for any debris to get caught on it in the pipeline.

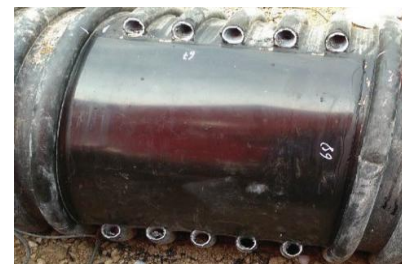
### STEP 3: EXTRUSION WELDING THE PATCH

To carry out extrusion welding repairs on site there needs to be a constant power source, no moisture in the weld zone and the work is to be carried out by a competent extrusion welder from the list of RSPs or an INFRAPIPE™ employee. The patch is made from HDPE sheet which can be heated to form the diameter or can be fabricated prior with cuts and welds to have the same radius as the pipe that requires repairing.

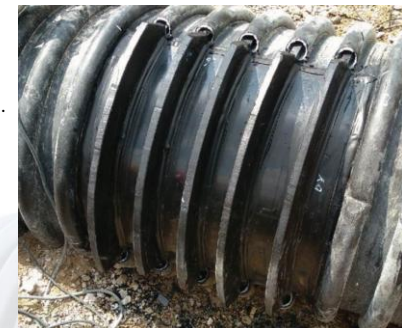
### STEP 4: ADDING THE STIFFENING RIBS

Once the patch is fitted in place and all 3 welds have been completed it is time to add the stiffening ribs to ensure the patch piece exceeds the required pipe strength. The stiffening ribs are also made from HDPE and are extrusion welded onto the exterior of the patch. After the welds have cooled the pipe can be backfilled in accordance with AS/NZS 2566.2:2002 – Buried flexible pipelines Part 2: Installation.

**If a test process is required for a certificate of conformity, the repair can then be tested with a spark welder.**

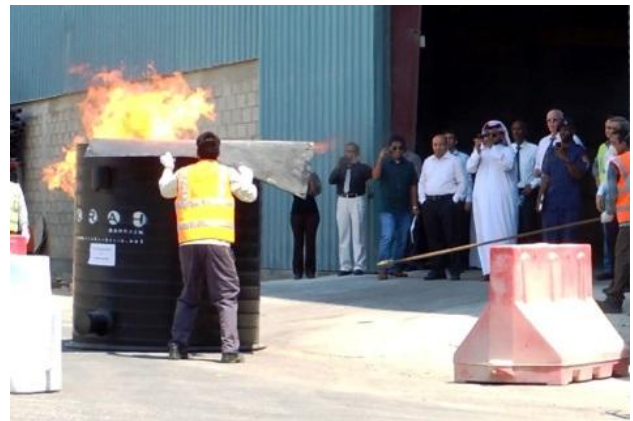
HDPE drainage pipes and fittings do not self-sustain in fires, the practical amount of flammable material and the volume of airflow needed to reach the consistent temperatures required is too great for the vast majority of applications. A material that will stay in place (not drain away) is typically not intense enough and the quantity needed then blocks the very airflow it requires. This has been tested overseas (to the satisfaction of the appropriate authorities), as these photos from tests by the Bahrain government Ministry of Works show:
