## MICROPLASTICS AND PLASTIC PIPES

### SHORT SUMMARY

Plastic pipes for drinking water purpose made of 9 different materials have in two studies been tested in conditions, similar to normal use. Based on the applied methods, no levels of microplastics above the detection limit were found in the samples.

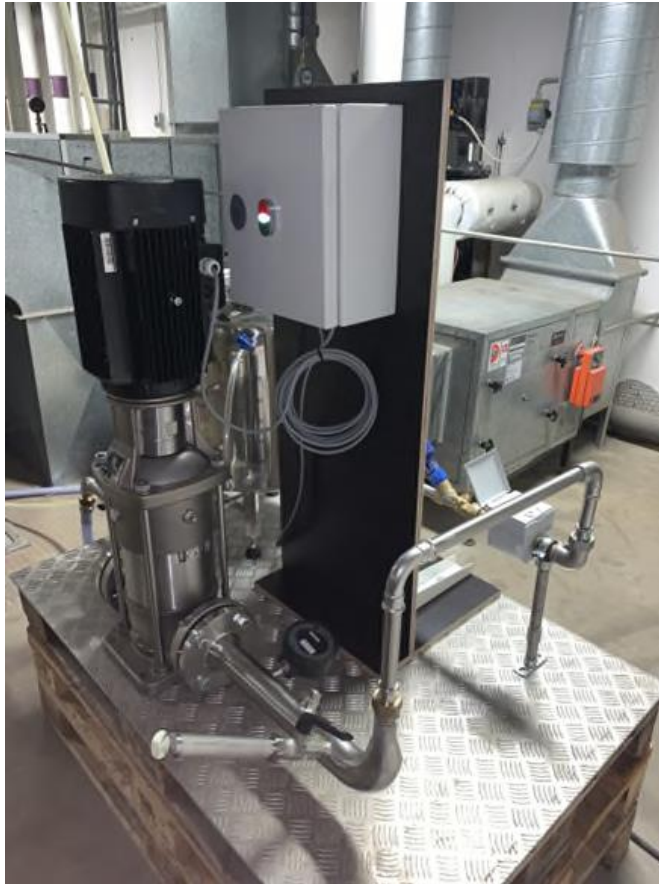
The pipes are assembled in a way that resembles daily routine work with deburring of ends, but with extra care in order to avoid internal impurities. The pipe between the red arrows shown is removed and replaced by the pipe to be tested.

- Thermometer, pressure gauge and flowmeter
- Coupling devices and piping for connecting test pipes
